JPL PUBLICATION 84-58

Alternate Nozzle Ablative Materials Program

N. A. Kimmel

September 1, 1984

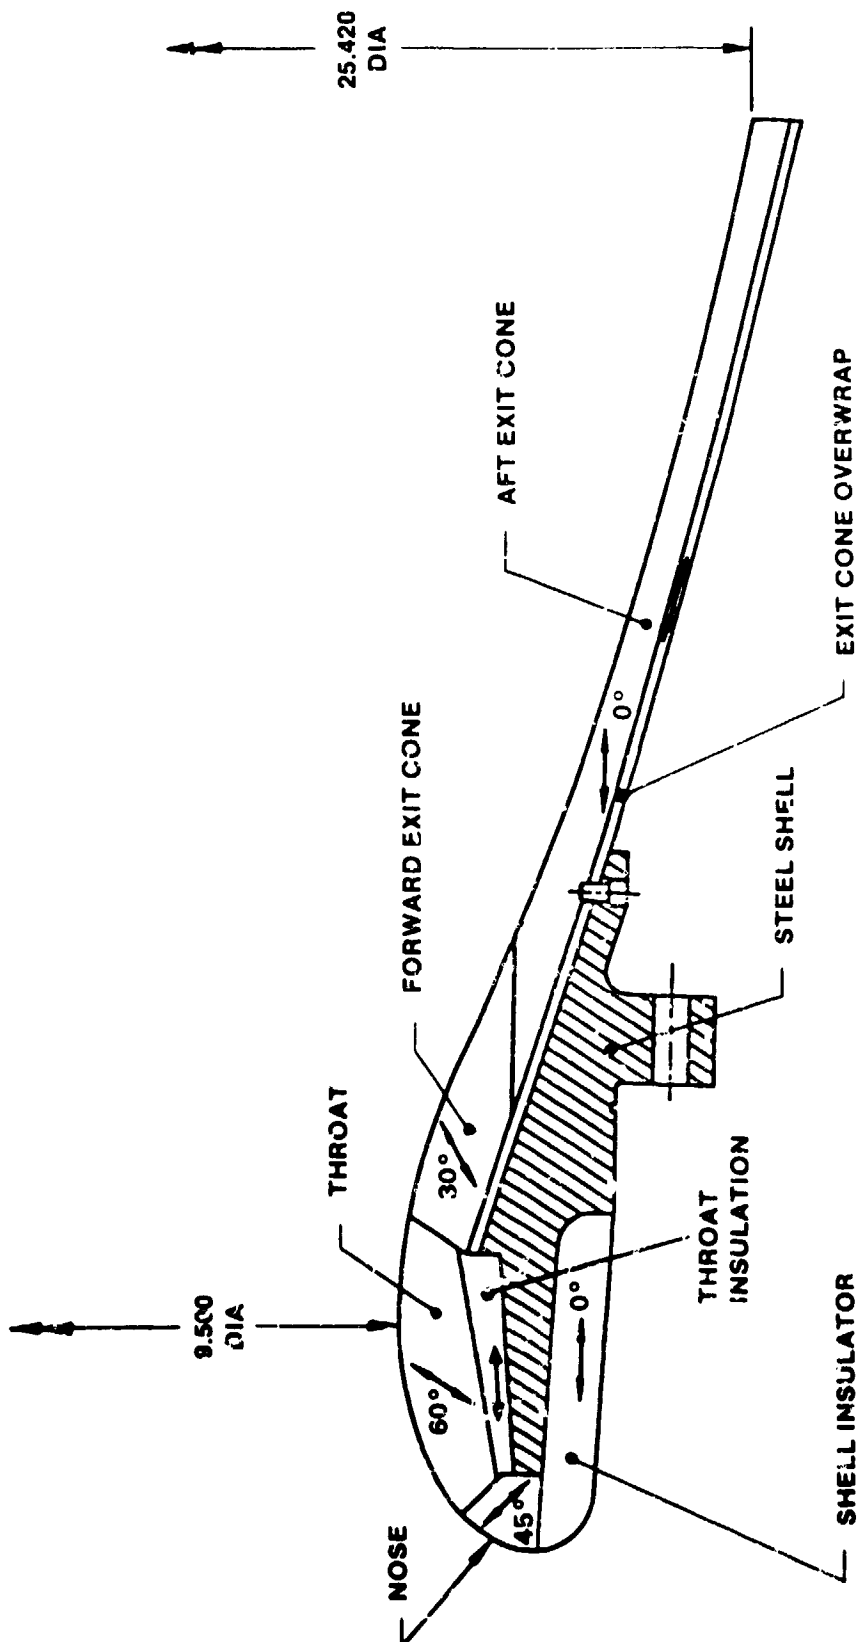
Figure 1. Subspace Shuttle Nozzle

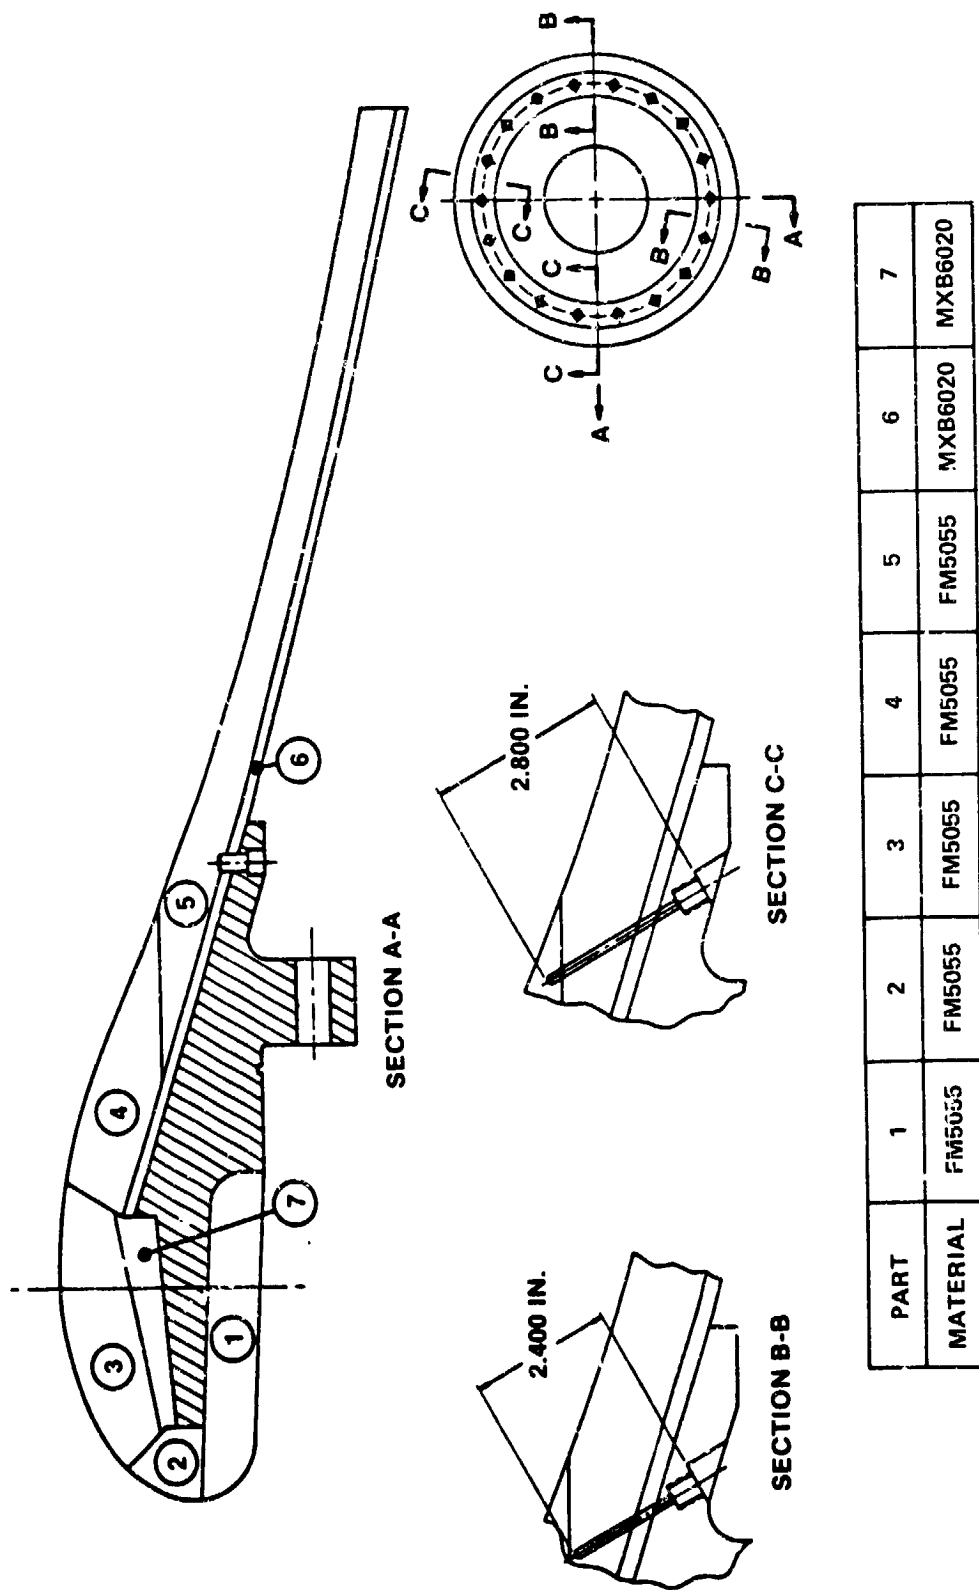
Figure 2. N-1 Nozzle Materials and Thermocouple Locations

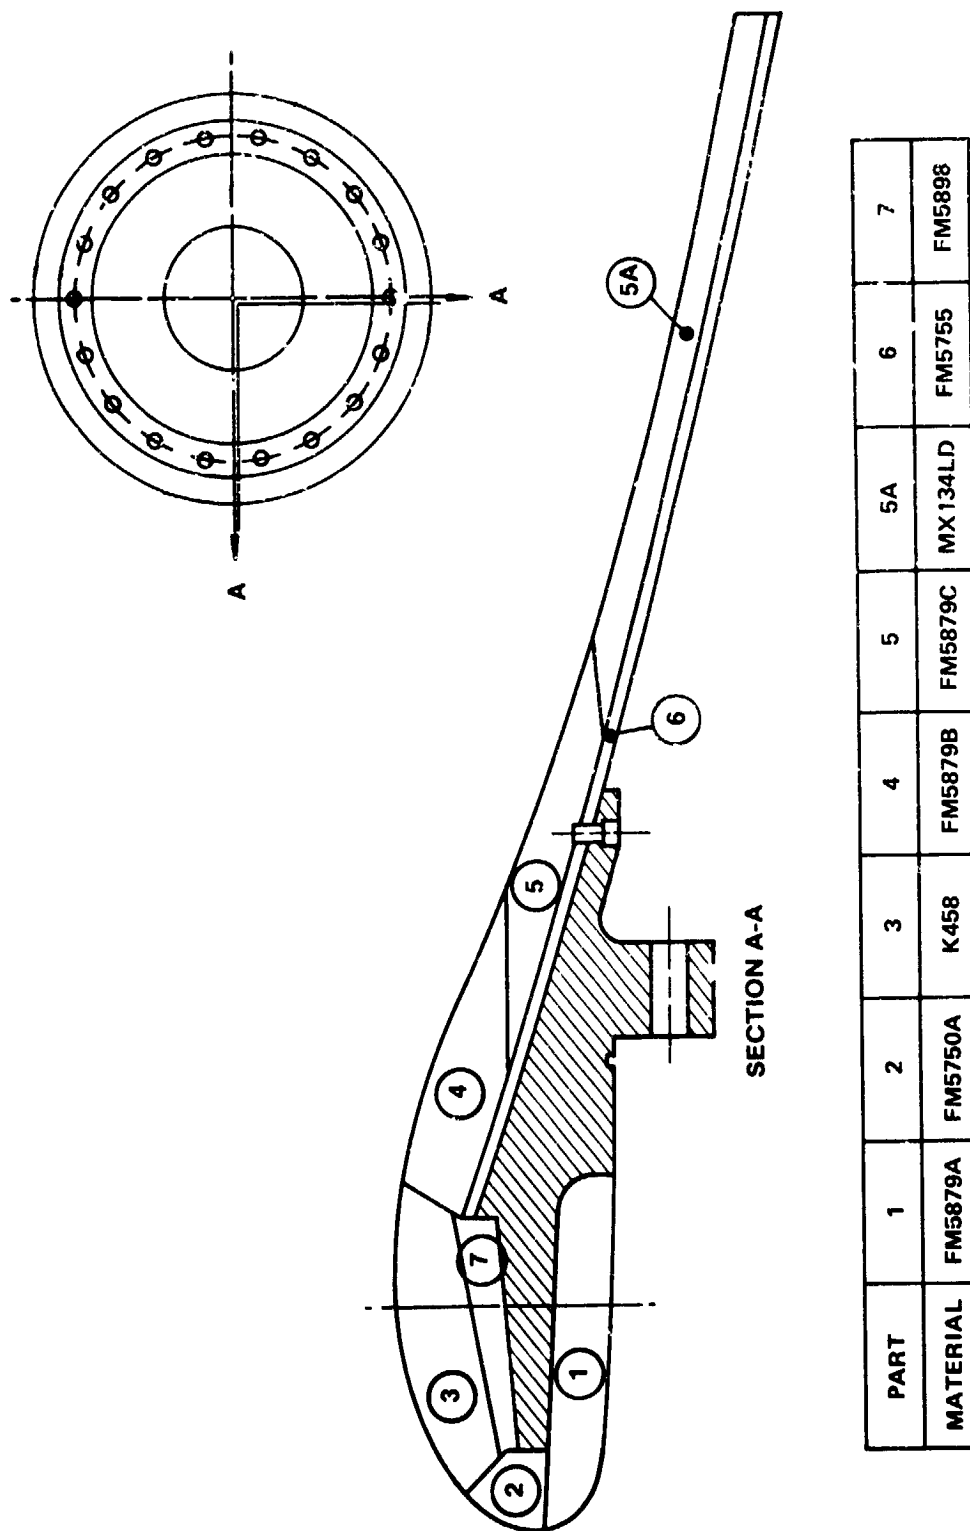
Figure 4. N-3 Nozzle Materials

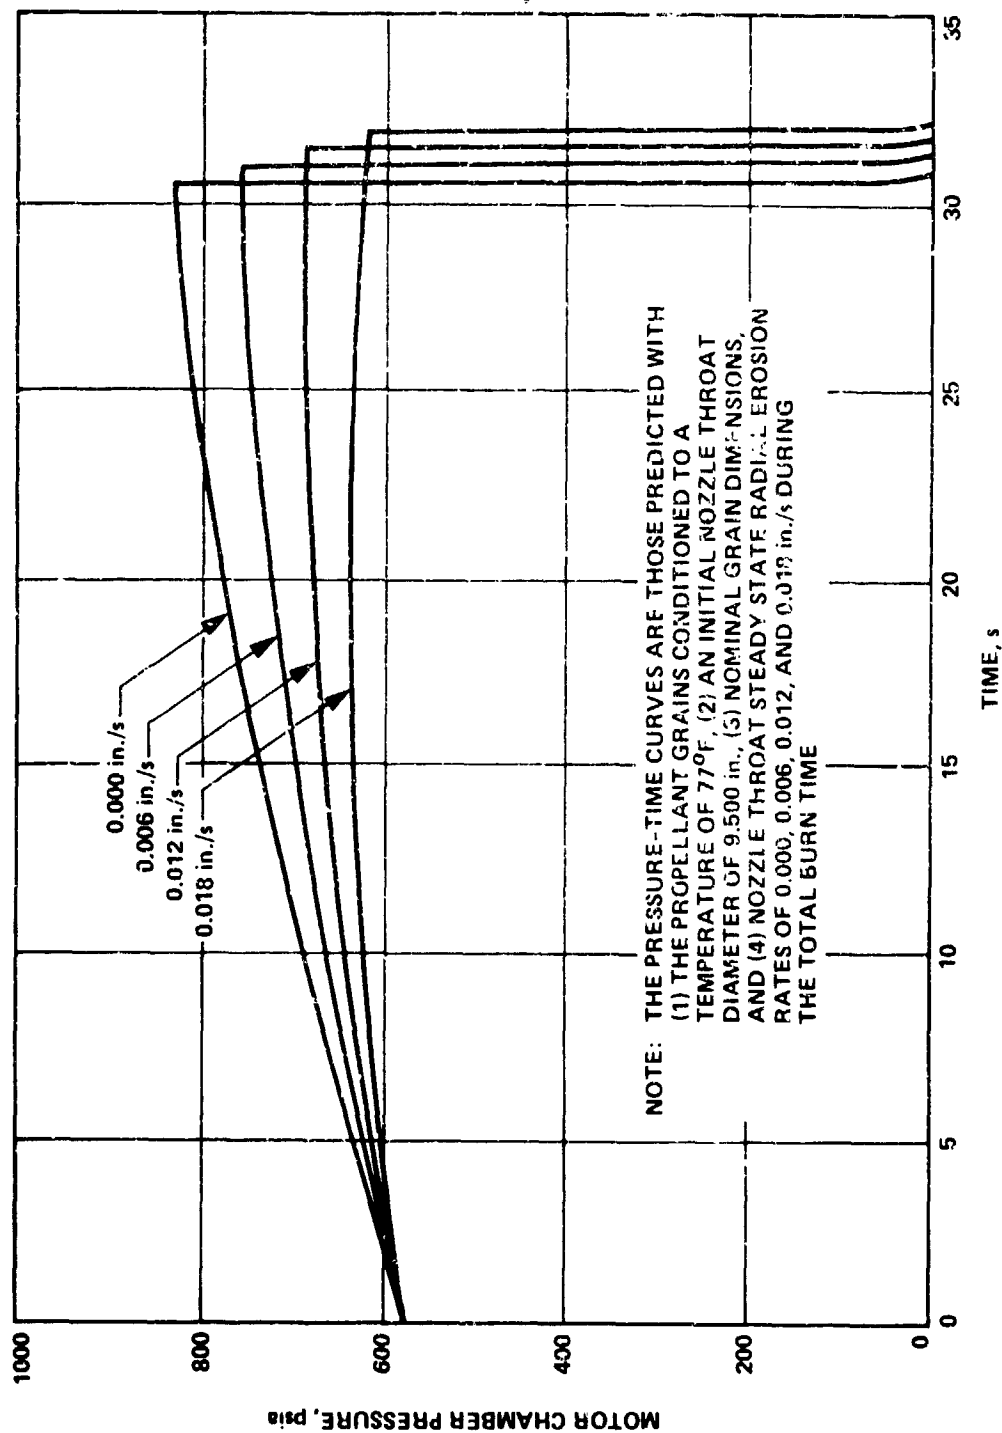
Figure 9. Predicted Chamber Pressure-Time Traces

The pressure-time curves for each motor firing were not predicted before each firing; however, the pressure-time traces for a nominal motor with a nozzle throat that erodes at constant radial erosion rates of 0.000, 0.006, 0.012, and 0.018 in./s, throughout the motor burn time, were calculated. The results of these calculations are plotted in the pressure-time traces as depicted in Fig. 9. It was expected that the actual traces would lie somewhere between the pressure-time traces shown for the 0.006 and 0.012 in./s cases of Fig. 9. The actual pressure-time histories for the N-1, N-2, N-3, and N-4 motor firings are shown in Figs. 10, 11, 12, and 13, respectively.

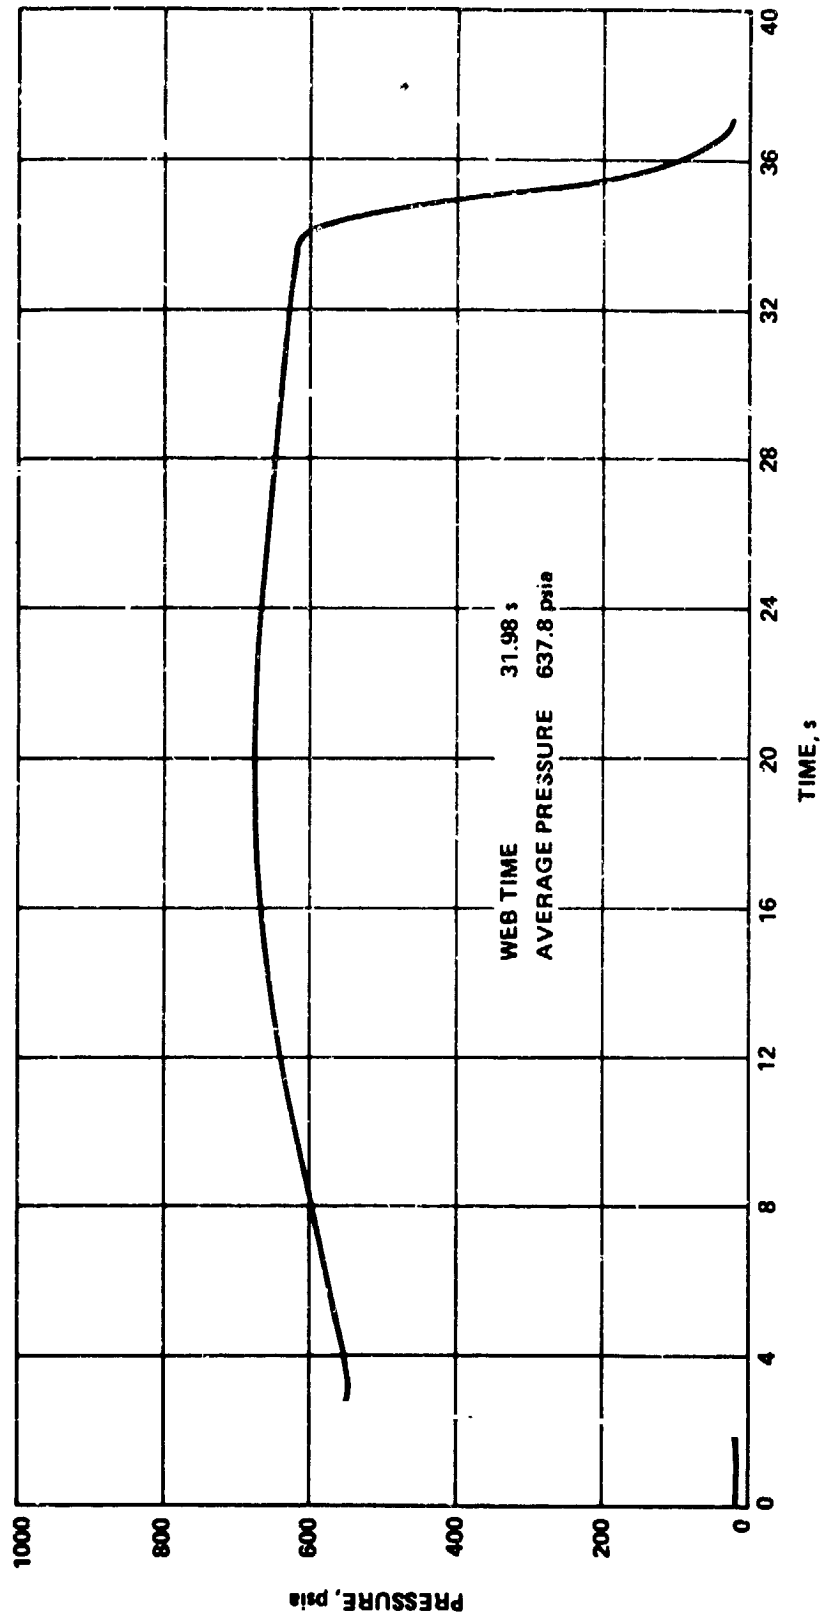
Figure 10. Test N-1 Motor Pressure-Time Curve

Figure 10 presents the pressure-time trace for the N-1 motor. The average web burn pressure was 637.8 psi and the web burn time was 31.98 sec.

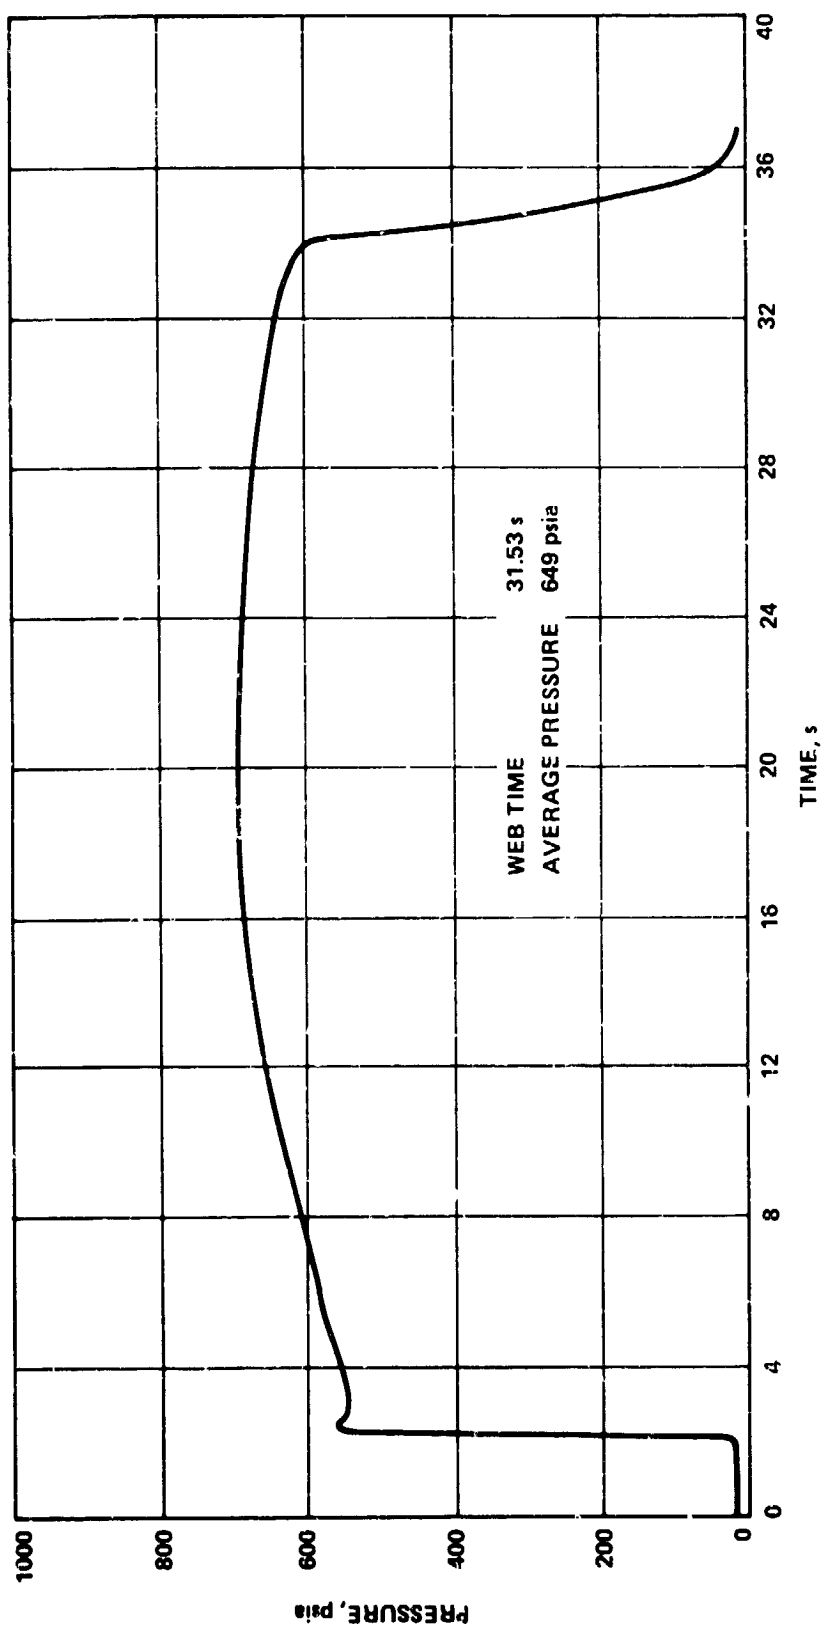
Figure 11. Test N-2 Motor Pressure-Time Curve

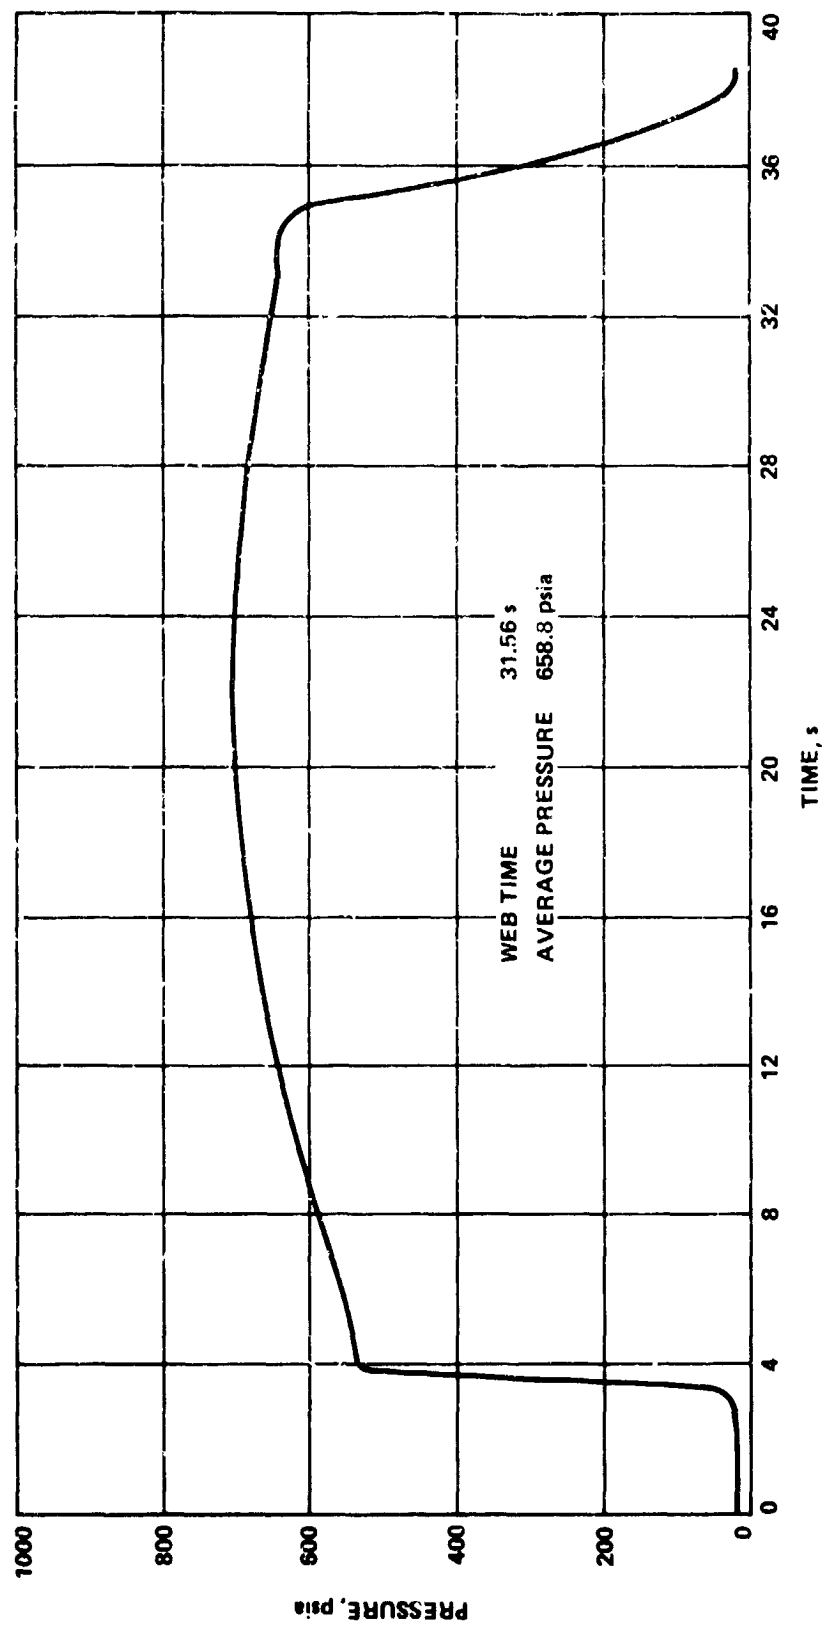
Figure 12. Test N-3 Motor Pressure-Time Curve

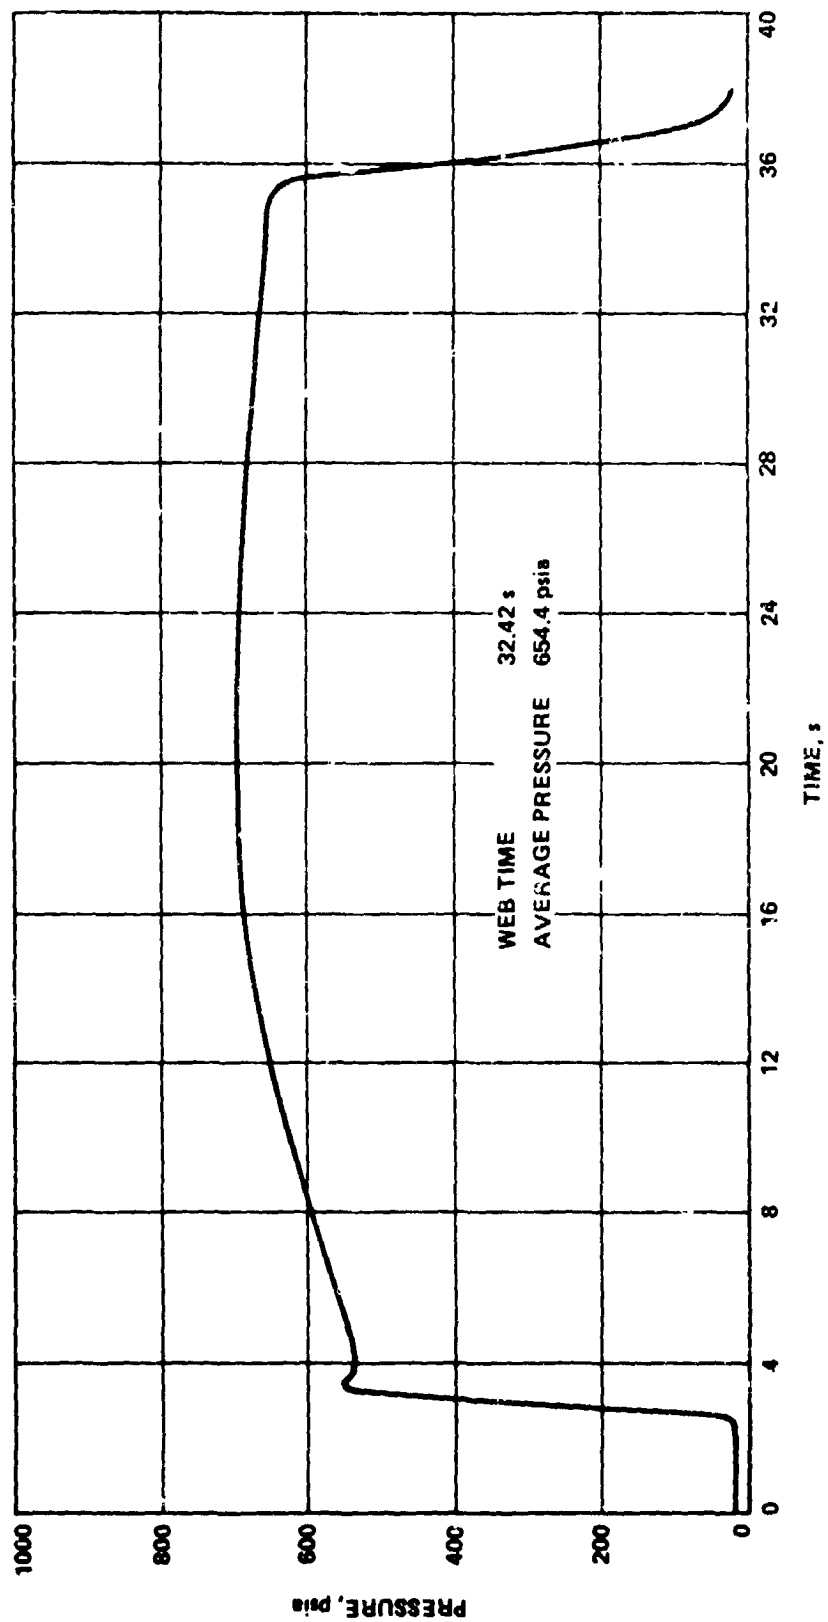
Figure 13. Test N-4 Motor Pressure-Time Curve

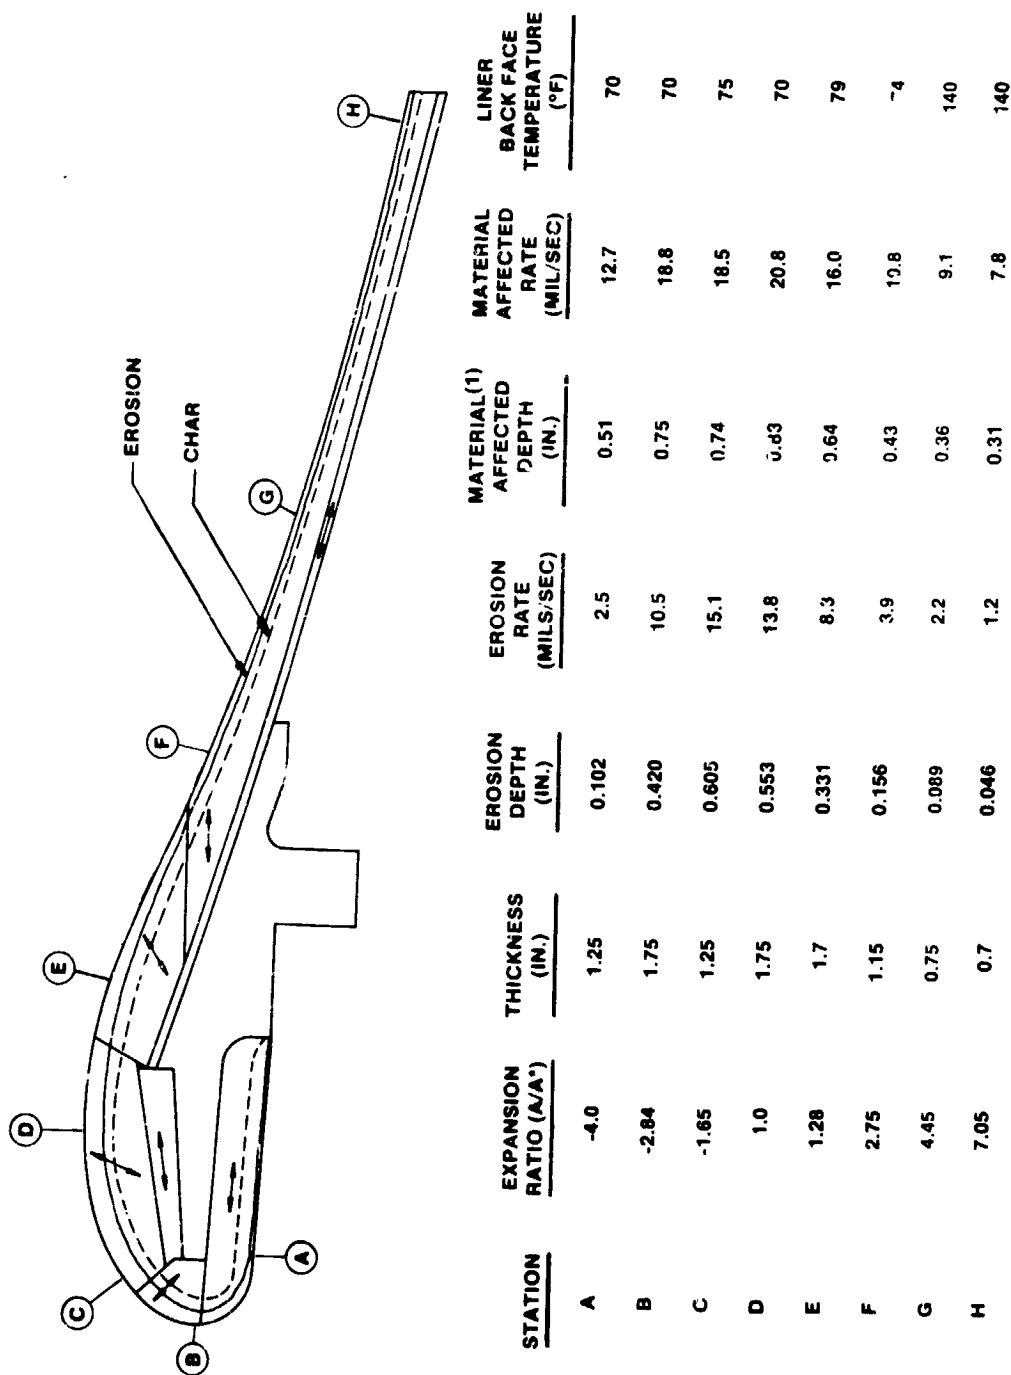
(1) BASED UPON CHAR ZONE CRITERION = 0.27 OR $\rho_s = 78 \frac{\text{LB}}{\text{FT}^3}$ WHERE $\rho_o = 91.3$
 $\rho_c = 73.4$
 MATERIAL AFFECTED DEPTH = EROSION + CHAR DEPTH

Figure 4. N-1 Nozzle Predicted Erosion and Char Thickness and Backside Temperatures

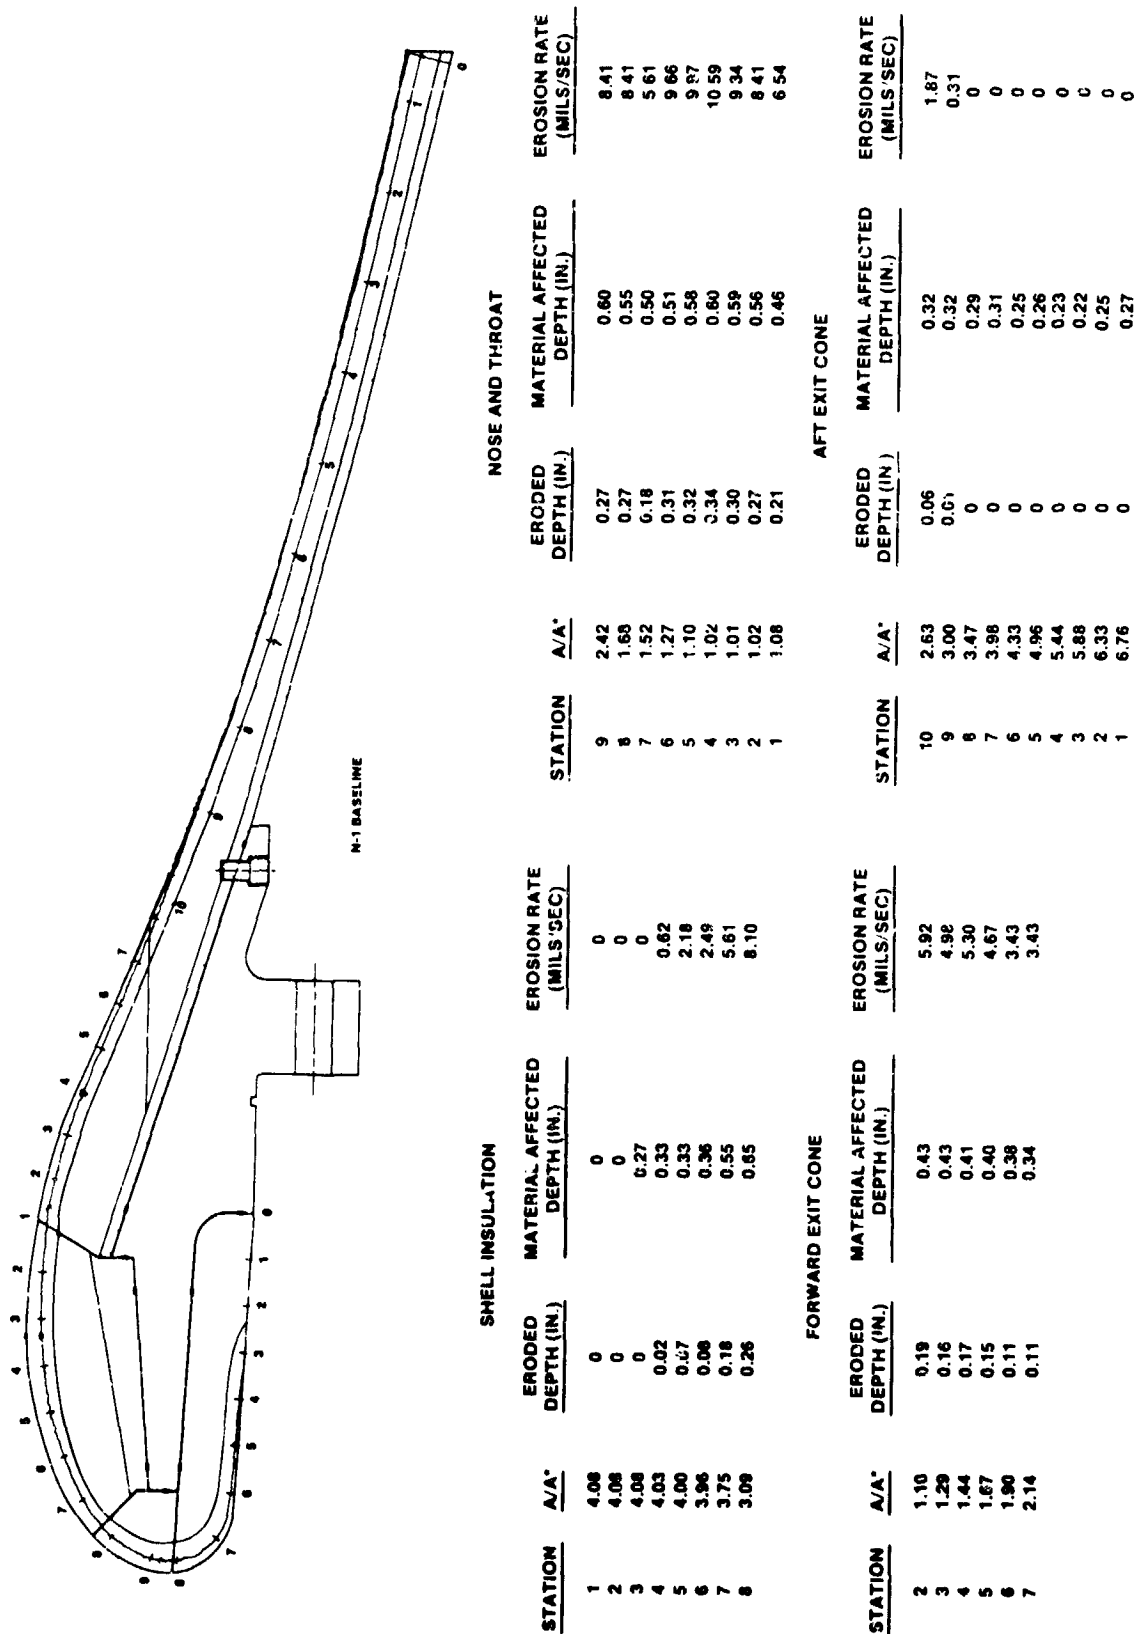
Figure 11. N-1 Measured Erosion and Char Data (0 Deg)

Erosion rates were calculated using average web burn time. Measured throat erosion rates were calculated using one-half of the average difference of six prefire and postfire diametrical throat measurements. Erosion at other locations was recorded using measurements taken from the cross sectioned nozzle. Char thickness was obtained by direct measurement taken on the sectioned nozzle components.

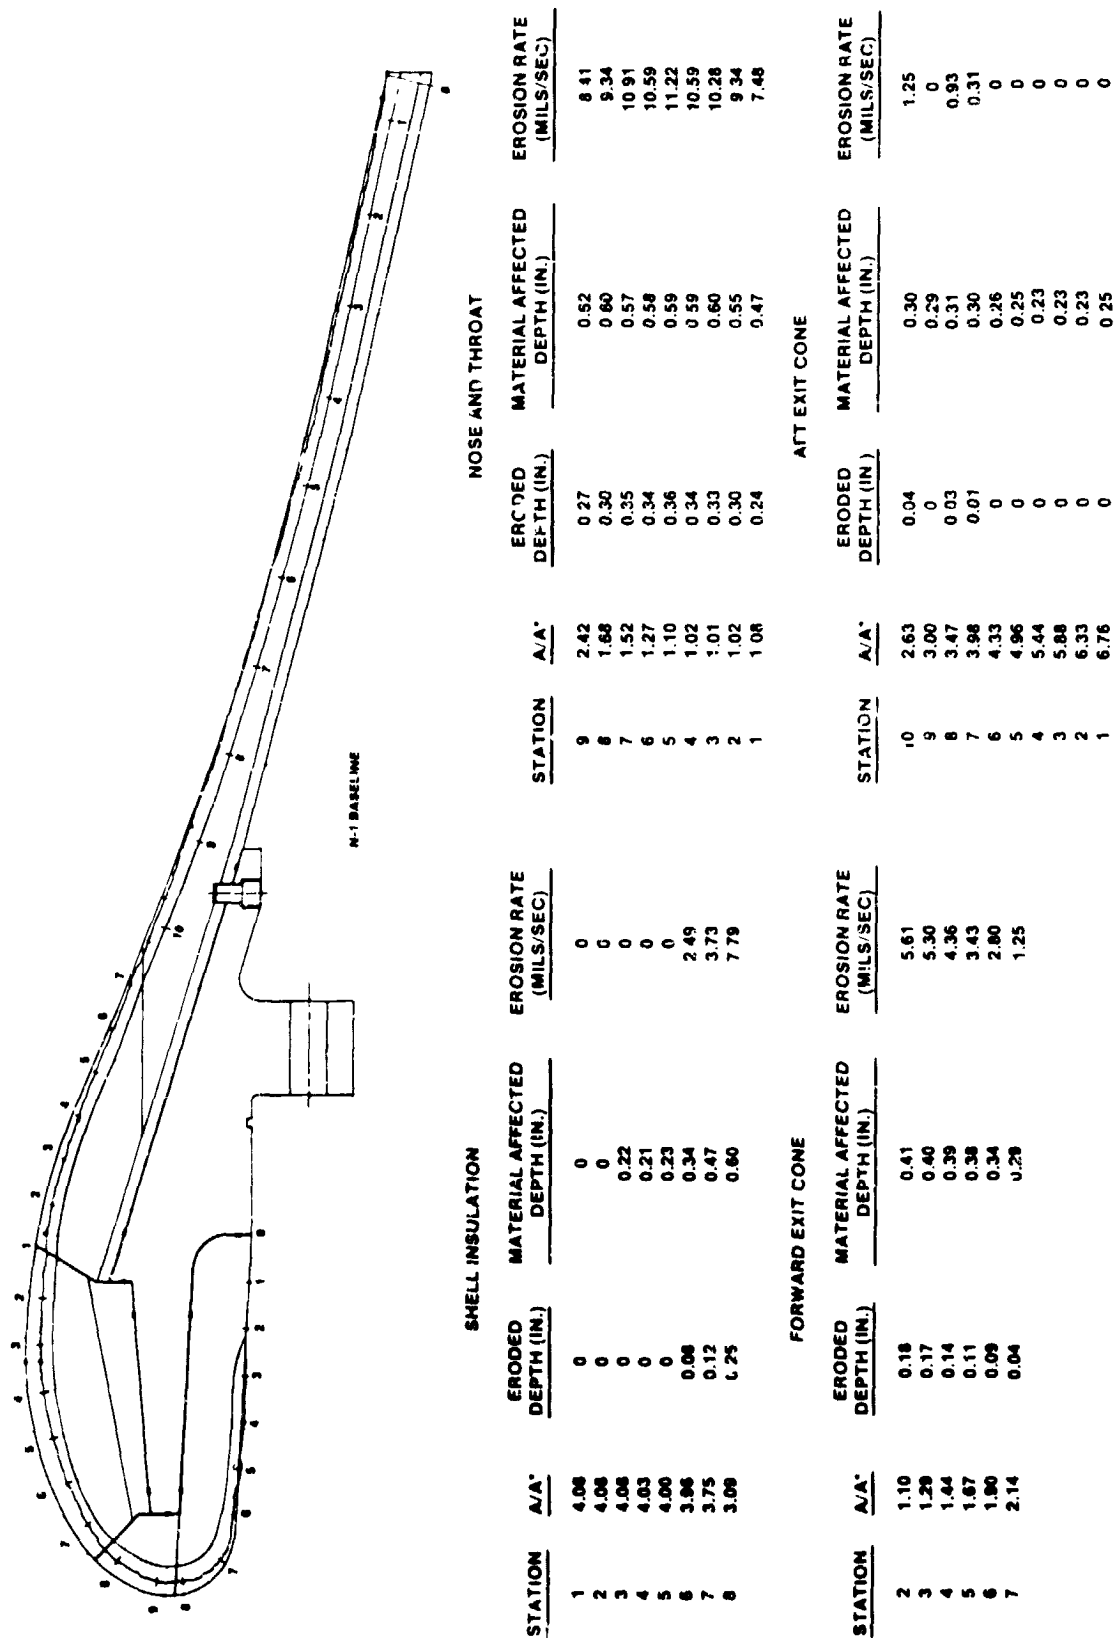
Figure 13. N-1 Nozzle Erosion and Char Data (180 Deg)

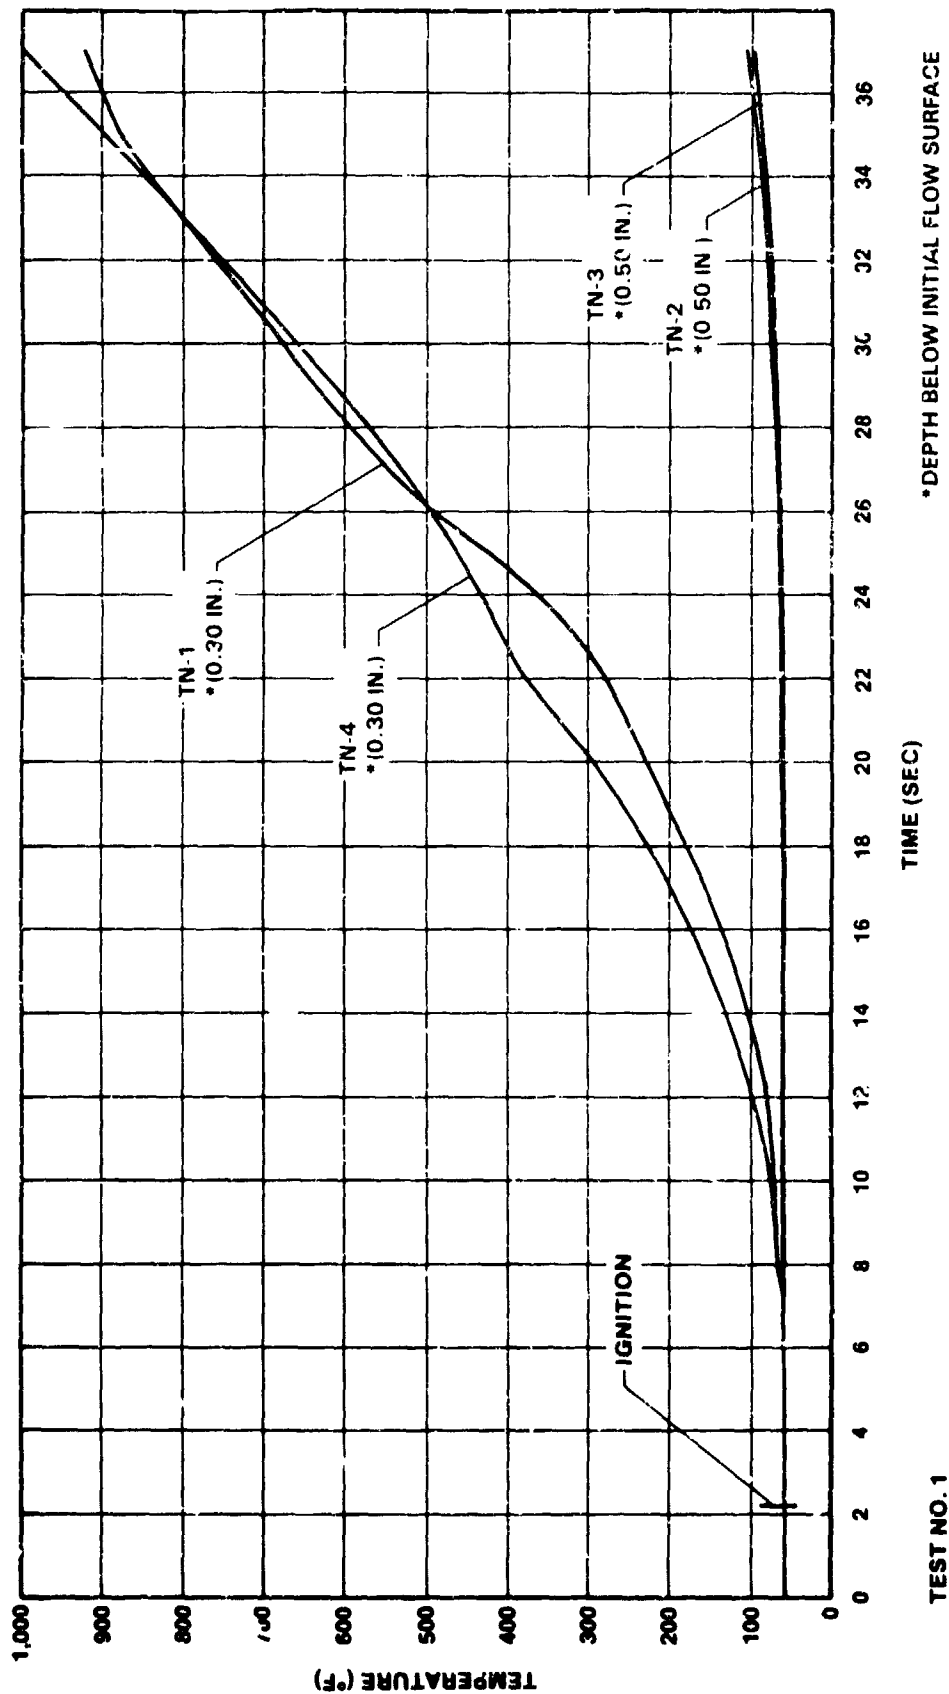
Figure 23. N-1 Nozzle Temperature Versus Time

Just prior to test, all thermocouples read 60°F. The initial temperature rise for the shallower thermocouples, TN-1 and TN-4, occurred at T + 7.4 sec and continued to rise throughout the test. Temperatures of 1,000°F (TN-4) and 920°F (TN-1) were recorded at 37.00 sec. TN-2 and TN-3, the deeper thermocouples, showed a gradual temperature rise over motor burn time. TN-3 recorded a temperature of 110°F at 37 sec and TN-2 recorded a temperature of 100°F.

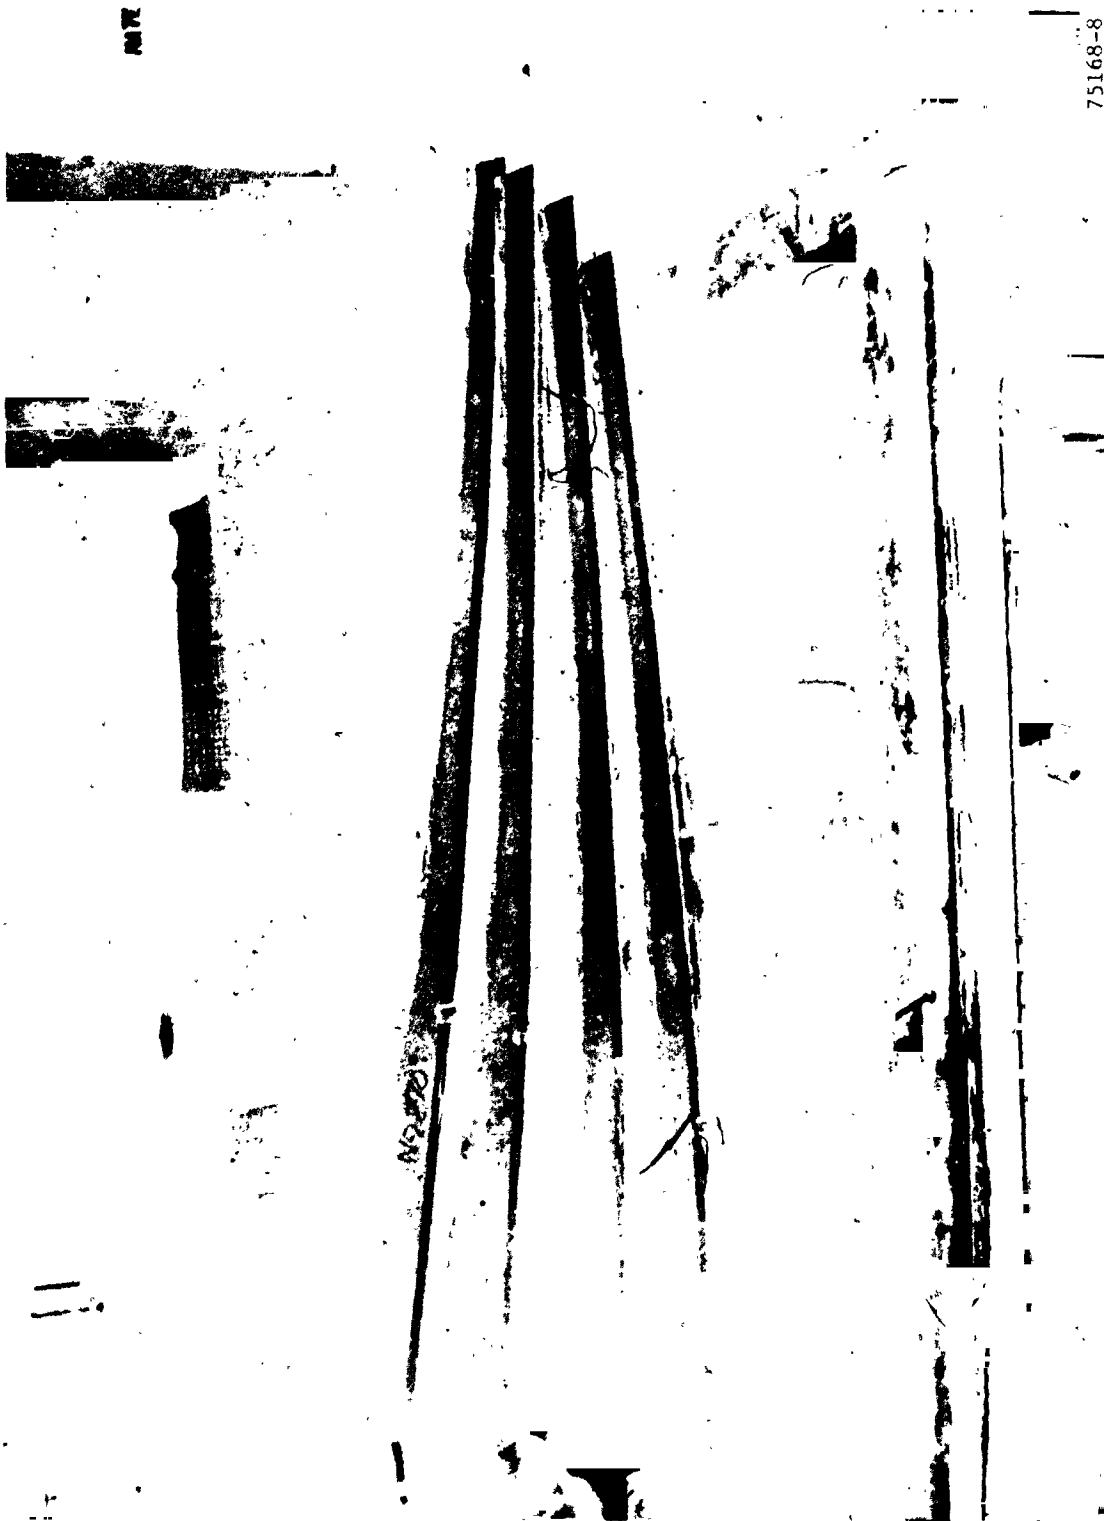
Figure 9. N-2 Nozzle Exit Cone

The aft cone charred, separated, and curled up material was quite soft and low in strength and showed several circumferential bands where apparent spalling had occurred. The ceramic mat throat insulator was not heat affected (charred); but, during metal shell refurbishment, it fractured across the plies near the center of the part, indicating low strength of the material.

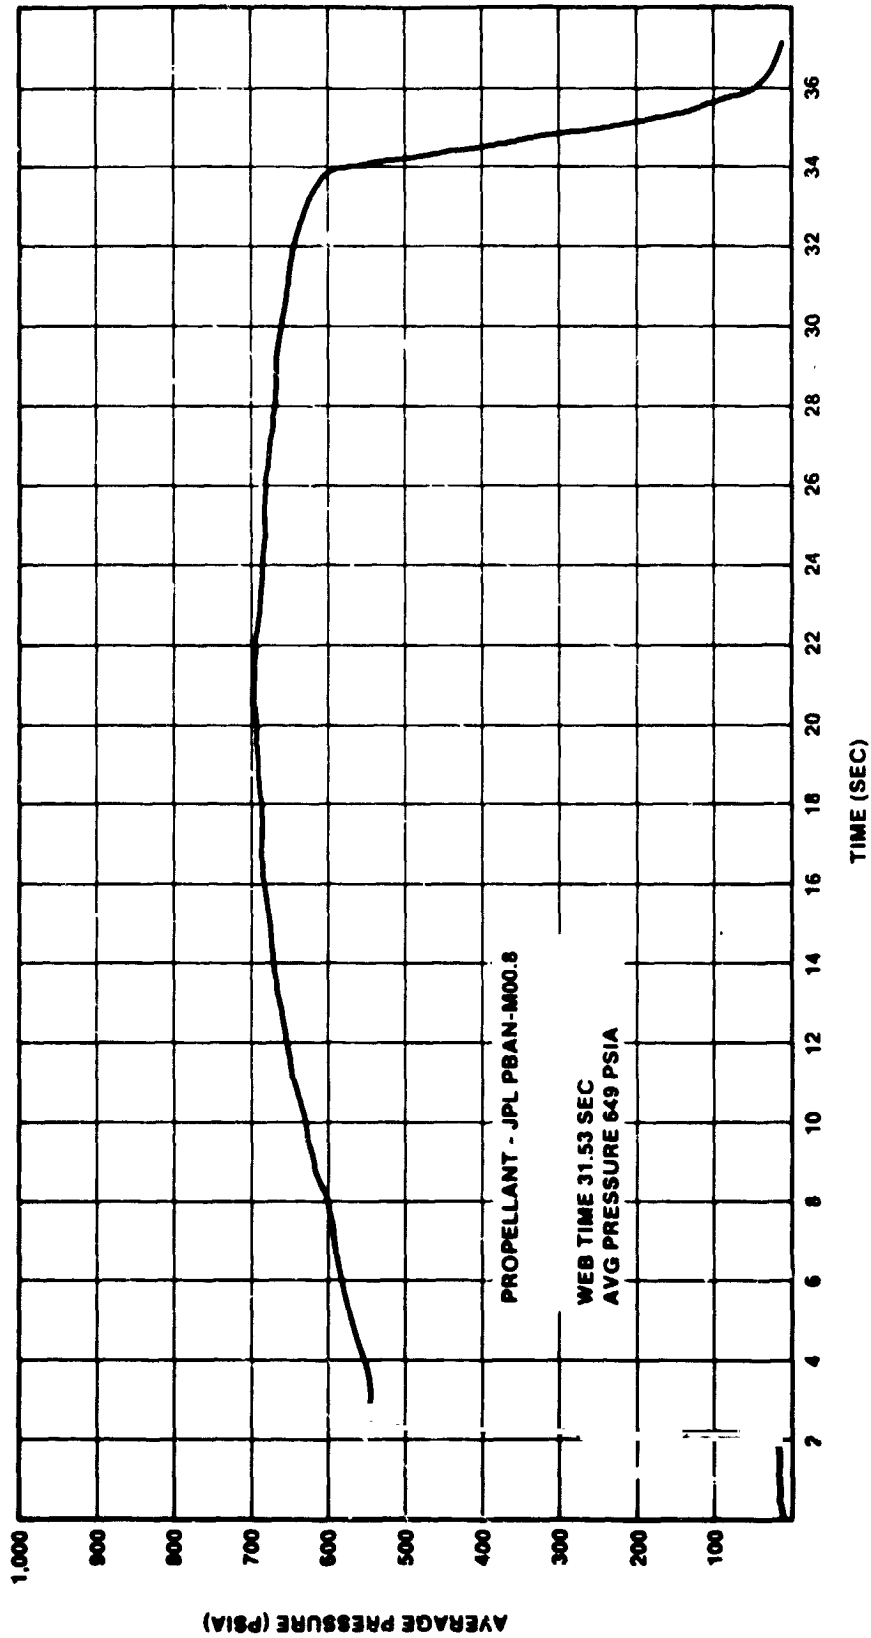
Figure 13. Test No. 2 Pressure-Time Trace

Figure 12 shows the JPL test motor, and Figure 13 presents the pressure-time trace for the N-2 motor. The average web burn pressure was 649 psi and the web burn time was 31.53 sec.
